DALI-Gateway KNX plus

Update Tool

1 General

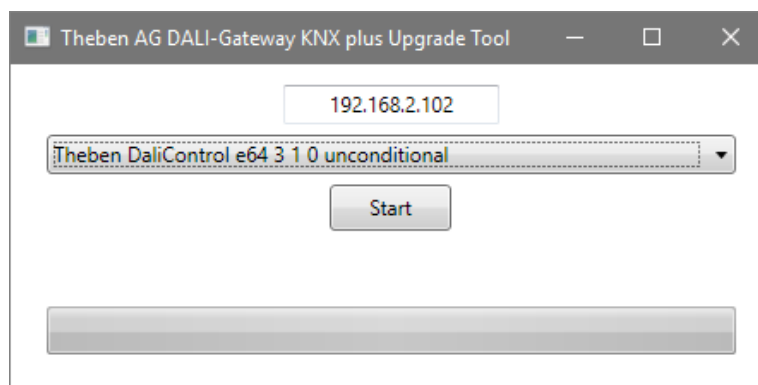
After the programme has been started the following entry window appears:

To start the upgrade, enter the IP address of the device that you would like to upgrade. Double-click on the displayed IP address to open the entry field.

You can now edit the IP address and ensure it is correctly set to the value required. Press the OK button to transfer the address to the main window.

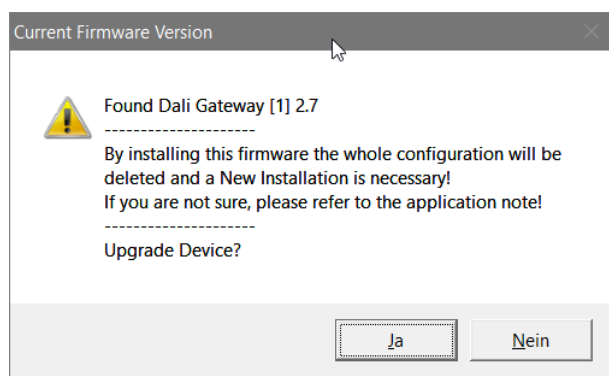
The upgrade tool first checks the current firmware version of the Dali gateway and informs the user via an information window of the firmware version that has been used up to now.

After acknowledgement the firmware data are transferred to the device memory via FTP. A progress indicator informs about the current status of the transfer. Once the upgrade files have been successfully transferred, a device reset is required. After the reset the device starts with the new firmware version.

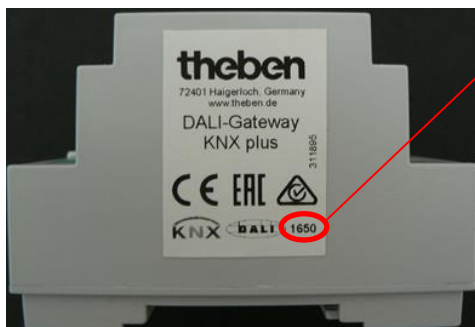
Information

Production date code:
